Volume II

Appendix D.15

Maintenance, Material, and Management Inputs

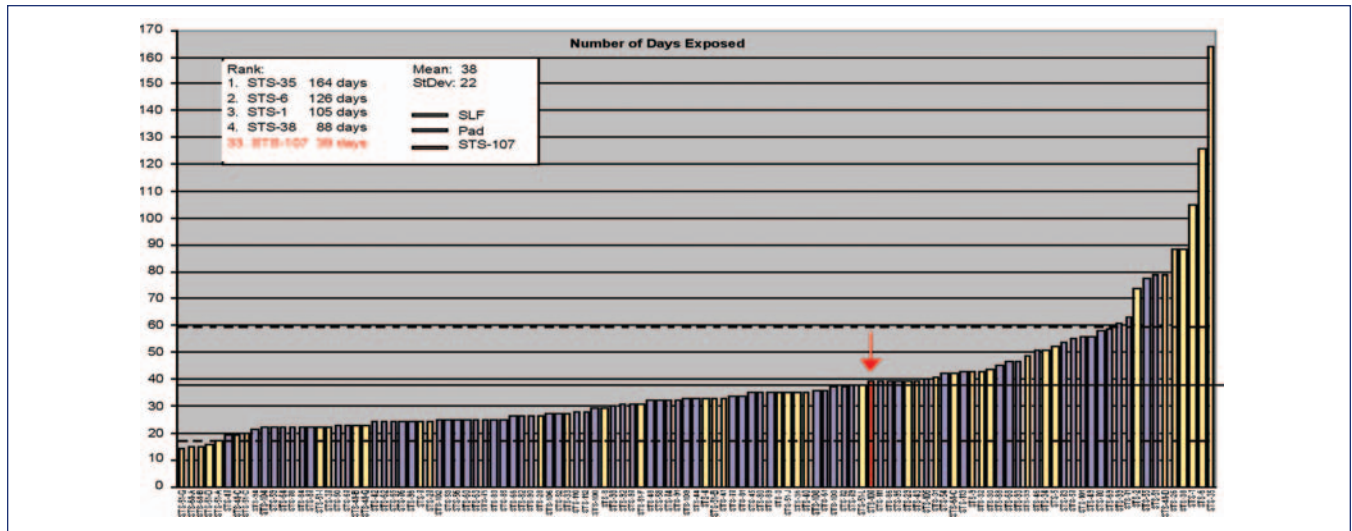
The 164-day exposure for STS-35 occurred over eight months and four launch attempts, from April to December 1990, and illustrates the complexities associated with launching Shuttles. OV-102's initial rollout was on April 22; a Freon system repair added 14 days, but the launch was scrubbed on May 30 due to a Main Propulsion System (MPS) liquid hydrogen (LH2) leak. After troubleshooting and maintenance preparations, OV-102 was rolled back to the VAB on June 12. It was rolled out a second time on August 9, but required a 6-day stand down for telemetry repair. Its September 1 launch was scrubbed on 5 September due to another hydrogen leak. Following maintenance at the pad, the next launch attempt was scrubbed on September 18, due to another MPS LH2 leak. After further troubleshooting and maintenance preps, it was rolled back on October 9. Rollout next occurred on October 14, followed by special LH2 tanking tests for two additional days; however, Auxiliary Power Unit water valve problems and follow-on maintenance and servicing took another 16 days. OV-102 finally launched successfully on December 2. It should be noted that STS-35 is an outlier when compared with all other Shuttle launches. Figure 1.3.2 shows a comparison of exposure time by mission.

Figure 1.3.2. Exposure by Mission: red arrow depicts STS-107, STS-35 is at far right.

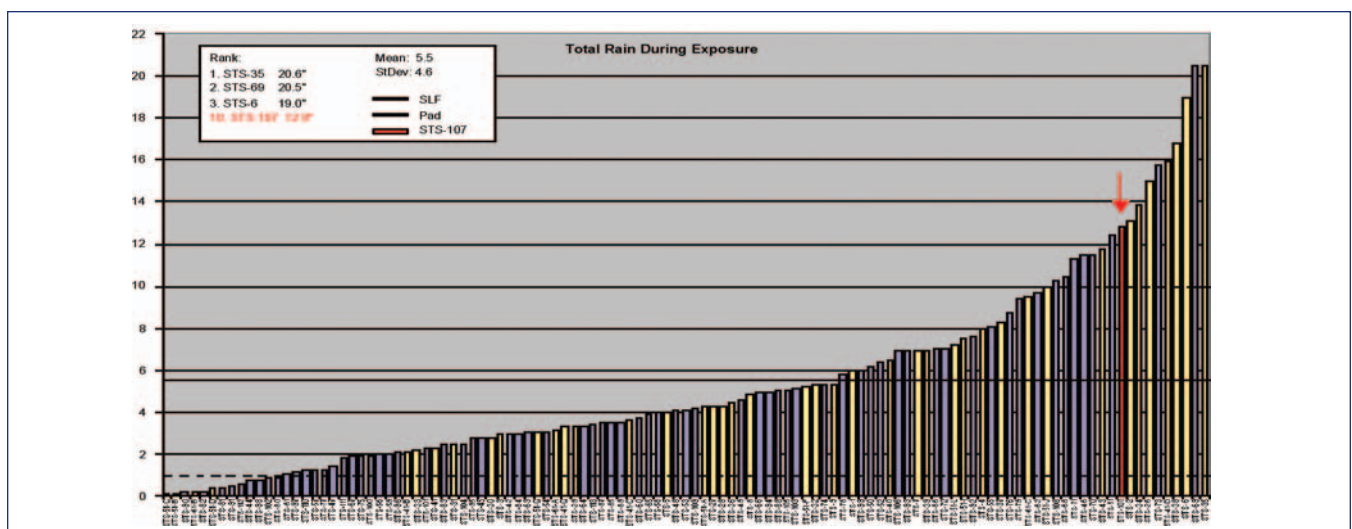
Environmental exposure constraints are clearly outlined in RTOMI S0018.100, Adverse Environmental and Lightning Monitoring at LC39. This publication includes guidance on actions to minimize exposure to rain, hail, winds, freezing temperatures, or tornados. In spite of this existing guidance, circumstances such as those related above, both on the launch pad and during ferry operations, contribute to more exposure than is desirable. Figure 1.3.5 shows rain exposure data by launch, with STS-35 again being the worst case.

Figure 1.3.5. Total rain exposure by launch (arrow denotes STS-107; STS-35 at far right).

Corrosion is a problem in both military and commercial aviation. Due to the Shuttle's critical mission and limited design life (originally projected to be between 10 and 20 years), as well as its now projected use for as much as another 20 years, strict adherence to existing guidance must be reemphasized on an ongoing basis. Furthermore, every opportunity to avoid/minimize/reduce exposure must be taken. Ground Operations should review launches where exposure was more than one standard deviation above or below the mean (Figure 1.3.5.) for lessons that may be applied to reduce exposure. Finally, as some amount of exposure is unavoidable, the Space Shuttle Program must have an intensive corrosion program of inspection, treatment, and prevention. Such a program will factor into the fledgling Service Life Extension Program.

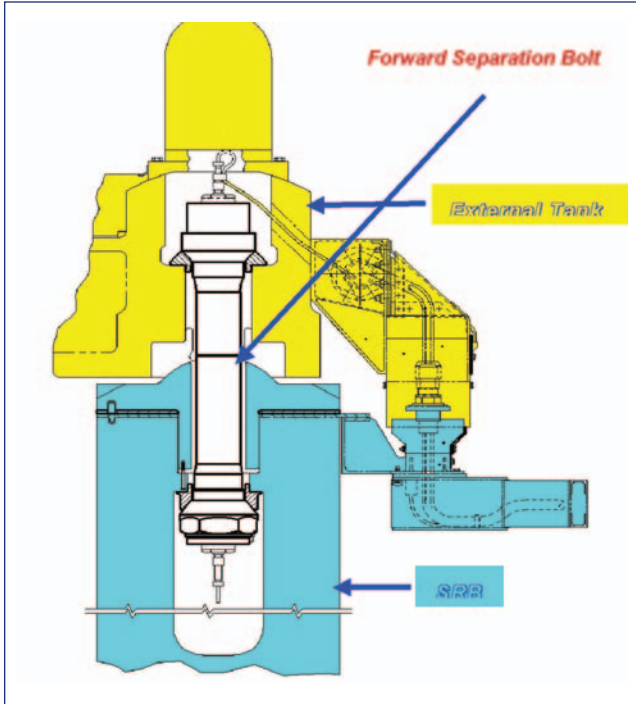
Figure 1.5.1. Diagram of a bolt catcher.

The External Tank (ET) is attached to the SRB Forward Skirt with one pyrotechnic separation bolt. At SRB separation, this bolt is pyrotechnically separated into two halves. On the ET side of the interface, a "bolt catcher" (see Figure 1.5.1) is mounted to catch the upper half of the fired separation bolt following NASA Standard Initiator (NSI) firing. The bolt catcher consists of a domed aluminum cover containing an aluminum honeycomb matrix to deform and absorb the bolt's energy as it is "caught." The bolt catcher is designed to prevent liberated objects from hitting the Orbiter after firing.

In the absence of physical evidence and adequate test data to measure bolt catcher performance against, it must be assumed that the bolt catcher could have played a role in damaging the left wing LESS of *Columbia*. Specifically, the dome could have catastrophically failed at the weld, SLA coating could have come off (in adequately large quantity to damage the shuttle), or a bolt/insert could have failed to hold. Review of radar imaging data reveals objects were liberated from the STS-107 stack at the time of SRB separation (approximately 126 seconds).⁷ Much of this debris is from known sources aft of the Orbiter, and do not present a threat to the vehicle. However, the radar data has been inconclusive, to date, as to whether the bolt catcher could have been a part of the separation debris. Several other methods will be used to investigate the bolt catcher's potential as a source of damage to the LESS Thermal Protection System on *Columbia*. First, review of existing, but limited, data from STS-107. Second, a new set of tests of the as-flown configuration is being performed to better characterize the bolt catcher performance parameters.

The first two Harris bolt catchers failed at an equivalent static load of 54 KIPs (± 2 percent), and 57 KIPs (± 2 percent), respectively. The third static test (using a Summa manufactured catcher) produced the most alarming results. This catcher failed at 44 KIPs (± 2 percent). The second dynamic test of a separation bolt firing produced a derived load on the bolt catcher of 46 KIPs (± 10 percent). If these results are consistent with the remaining tests, the factor of safety would be 0.956 for the bolt catcher and is significantly under the NASA design requirement of 1.4. The results of this test do not eliminate the bolt catcher from fault tree consideration and may imply a significant weakness in NASA’s method of certification of critical systems by analysis and similarity.

Remove all remaining Summa and Harris catchers from service until testing is complete (including x-ray evaluation of all welds). Attempt to determine the Factor Of Safety on the Summa bolt catcher and the likelihood that STS-107 experienced an in flight failure of the Summa bolt catchers. Complete design upgrades to the SRB Bolt Catcher and perform qualification testing to certify the new configuration for flight use.

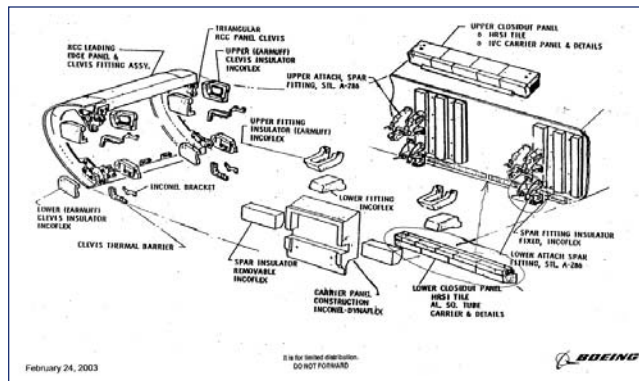
Figure 1.7.1. Details of the wing Leading Edge Support System.

The Orbiter’s wing leading edges are subjected to thermal and aerodynamic stresses during reentry. Proper inspection and maintenance of the LESS components, including attaching hardware, are essential to the system performing as designed/intended. The LESS consists of: 22 Reinforced Carbon-Carbon (RCC) panels on each wing; 44 carrier panels (22 on each wing’s upper and lower surface); numerous other components (such as spar insulators, clevis insulators, spanner beam insulators, spar attach fittings, and brackets); and hardware (including bolts, pins, and sleeves). See Figure 1.7.1 for details.

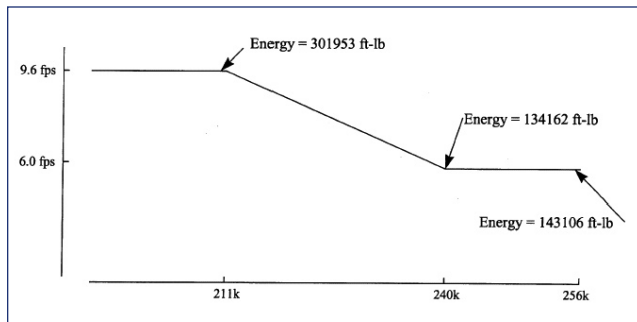
Figure 1.8.1. Energy Levels Based on Sink Rate/Landing Weight.

Based on a 6.7 fps sink rate and 11 knot crosswind, reconstructed gear loads were determined to be less than half of design limit load. Figure 1.8.1 shows how energy levels decrease with lower sink rates and landing weights and explains how design criteria can be exceeded without exceeding structural capability. This was verified using MADS accelerometer and strain gage data.

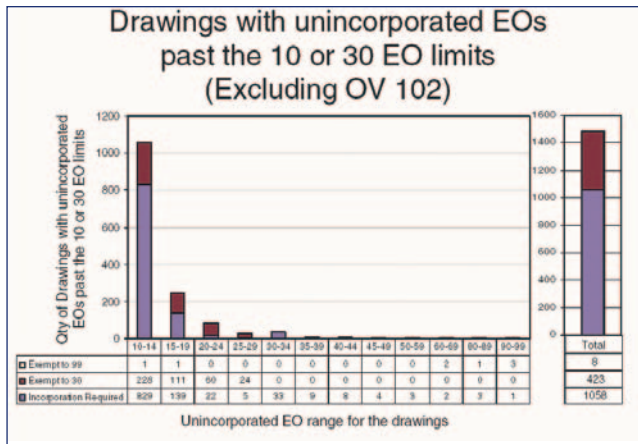
Figure 2.1.1. Unincorporated Engineering Order statistics.

reviewing the possibility of identifying the safety-critical drawings that should always be kept current. Recommendation 02-8: Identify drawings that are critical to flight safety, update them to include all EOs, and keep them current.”¹¹ (See Figures 2.1.1 and 2.1.2.)

Figures 2.1.1 and 2.1.2 show the status of the Shuttle Program's technical data in two graphics. The first shows the number of drawings that have greater than 10 unincorporated EOs each. The total figure, as mentioned above is 1,058. However, the significance of this number is further emphasized in the columns that have larger numbers of unincorporated changes but are supposed to be limited to no more than 10 unincorporated changes. Specifically, 90 have more than 20 EOs and 21 have over 40 unincorporated changes. The second graphic shows the number of total releases (new or updated technical drawings or specifications) by year. Over the last 10 years there has been a steady decrease in the number of new releases but incorporations have remained at a significantly lower level and at a relatively slow pace. In 2001 NASA accelerated this pace and has continued at this rate since then.

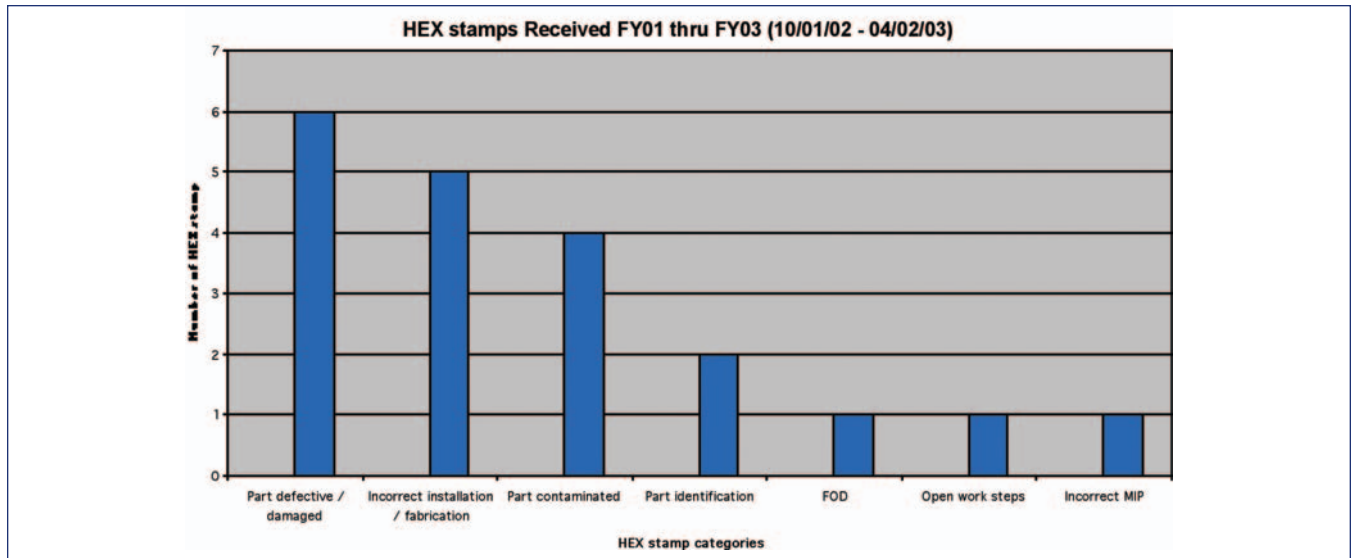
Figure 2.2.1. HEX stamps received between October 1, 2002 and April 2, 2003.

March 2003 that would have been subject to potential hex stamp use were 141,247. During that same period only 20 hex stamps were issued for various operations. (See Figure 2.2.1) HEX stamps received in FY2001, FY2002, and current FY2003 have been reviewed and the conclusion drawn is that the number of HEX stamps received compared to the number of inspection opportunities and hardware items completed/shipped provided too few data points for extensive analysis. According to several sources, this practice has been curtailed due to previous practices of using the stamps as a “hammer” against the contractor. The more common practice is for the inspector to refuse to buy the discrepant job, and offer to come back later once corrective action is taken. Such instances are not tracked by any measurement.

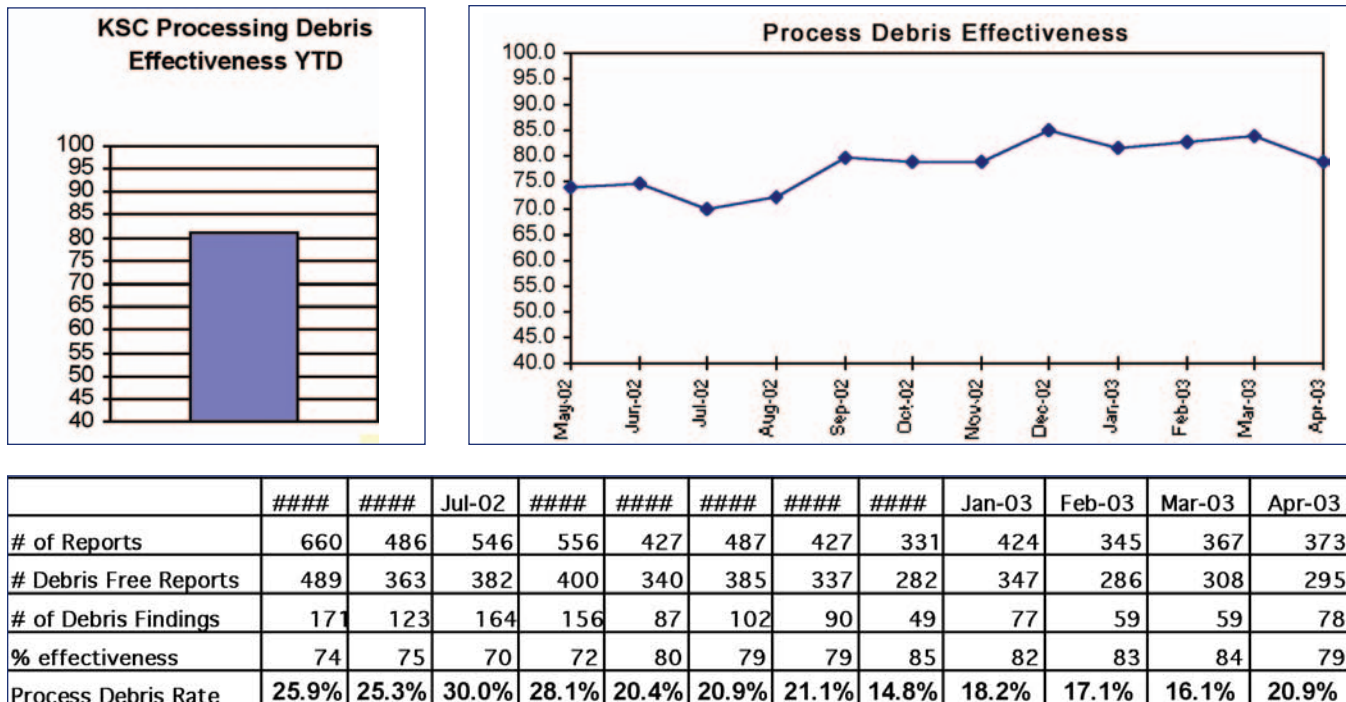
The NASA FOD program does have some outstanding aspects. The USA FOD program includes daily debris walk downs by management to ensure workers comply with the "clean as you go" USA policy. This program is noteworthy but statistics kept by USA show its success rate varies between 70 and 86 percent.²⁶ (See Figures 2.2.2 and 2.2.3.) The danger of migrating debris begins while the job is in work. FOD prevention must be considered as critical as clean up, regardless of timing and division of labor between USA and NASA quality responsibilities.

Figure 2.2.2. Process debris performance metrics.

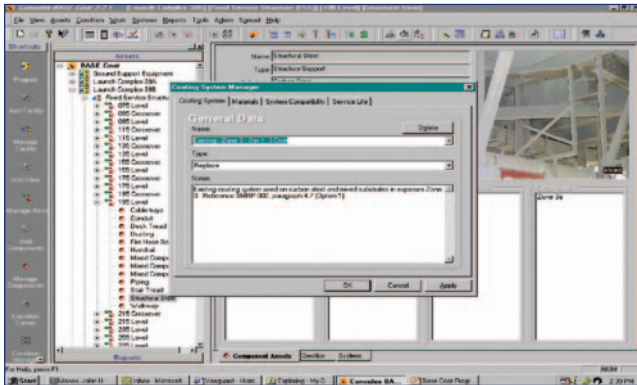
The GSS contractor has implemented an effective program to manage its facilities' corrosion problems. In 1995, Lockheed Space Operations (now part of USA) contracted Corpro (formerly Consulex) to develop a comprehensive software package to gather, archive and present a wide range of data concerning assessment, programming and execution of the facility corrosion control program. Corpro took a tool developed for the offshore oil industry and adapted it to KSC. The system, known as Basecoat, is in its third year of use. (See Figure 3.2.4) It integrates the corrosion protection

Figure 3.2.4. CorrPro Basecoat Software Example.
